model PBA6

Valve Button

INSTALLATION INSTRUCTIONS FOR 5874PBF.

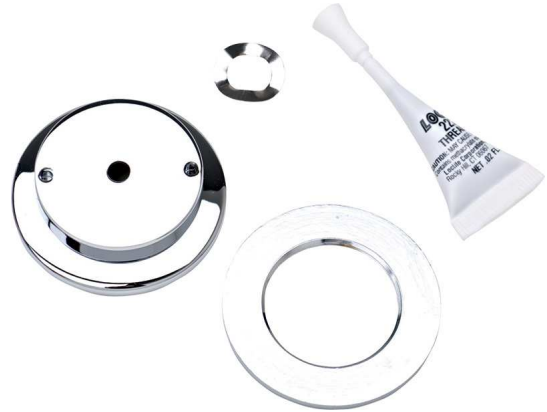
Model PBA6 flanged push button assembly is used with push button valve 5874, is made of polished chrome-plated brass, and includes the push button with front adjusting screw, operator, round locknut, snap ring, and wave washer. This model is used on flush mounted (not recessed) front stainless steel drinking fountain models.
